National Highway  
Traffic Safety  
Administration

Case Vehicle (A): 1999 Ford  
 Type: Ranger XL 4 x 4, 2-door pickup  
 Driver: 27-year-old male  
 CDC: 12-FYEW-2

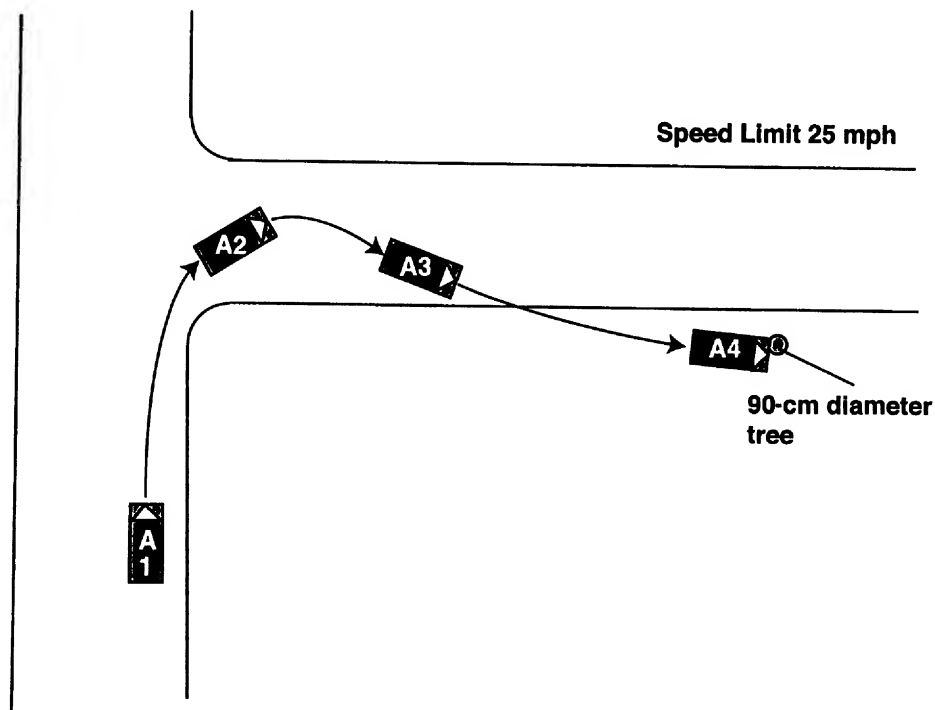
# ACCIDENT SCHEMATIC

(Slide 1) It was daytime, the sky was clear, and the roads were dry when case vehicle (A) was traveling north at an unknown speed on a two-lane asphalt road. (Slide 2) Case vehicle (A) made a right turn onto a two-lane gravel road, but was traveling too fast for the road surface conditions. (Slide 3) The driver of case vehicle (A) lost control of the vehicle and it exited the south edge of the road surface and (slide 4) struck a 90-cm diameter tree with its left front. The driver and right-front passenger were transported by ambulance to a local hospital and were treated and released. Case vehicle (A) was towed due to damage.

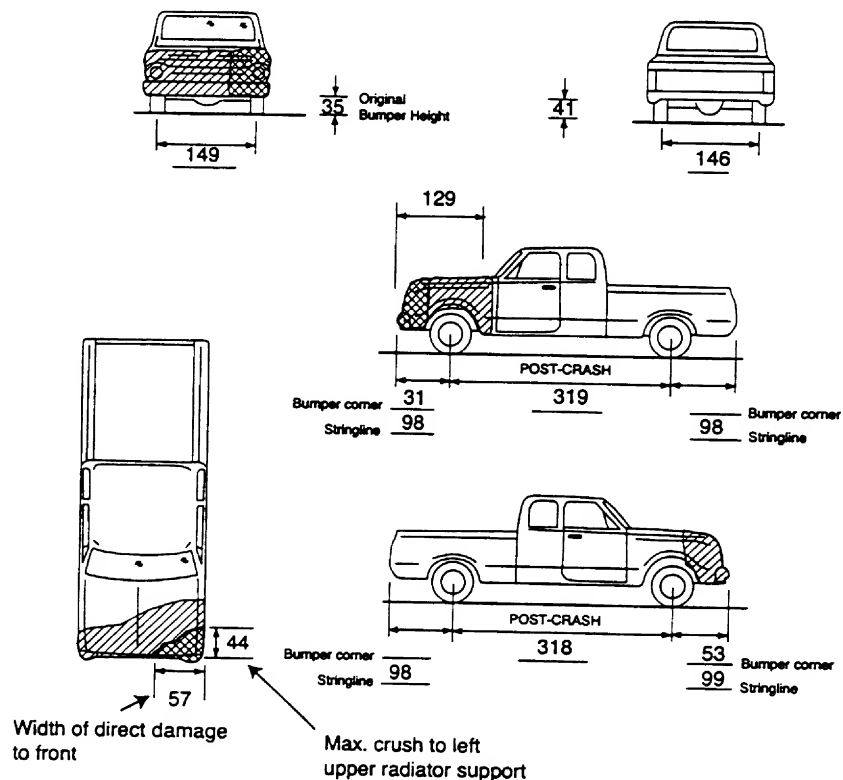
VEHICLE DAMAGE

(Slide 5) Damage to case vehicle (A) was moderate. (Slide 6) Direct damage began at the left bumper corner and extended 57 cm to the right, resulting in 40-percent vehicle overlap. (Slide 7) The maximum crush was 44 cm to the left upper radiator support.

Both front fenders, bumper and hood removed prior to inspection

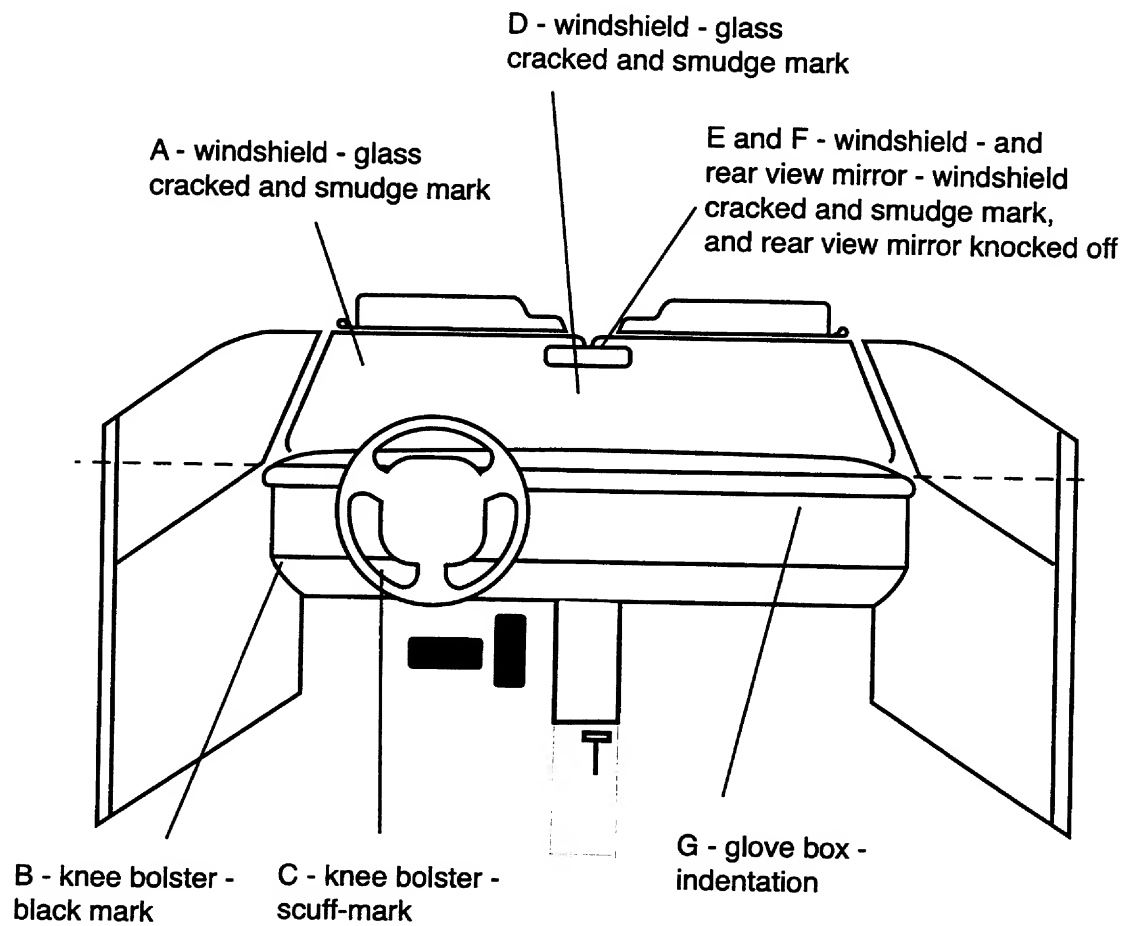
## VEHICLE OCCUPANT CONTACT DIAGRAM

Contact	Interior Component Contacted	Occupant No. if Known	Body Region if Known	Supporting Physical Evidence	Confidence Level of Contact Point
A	Windshield	DR		Glass cracked and smudge mark	2
B	Knee bolster	DR	Lt. knee	Black mark	3
C	Knee bolster	DR	Rt. knee	Scuff-mark	1
D	Windshield	RF	Head	Glass cracked and smudge mark	1
E	Windshield	RF	Head	Glass cracked and smudge mark	1
F	Rearview mirror	RF	Head	knocked off mount	1
G	Glove box	RF	Rt. knee	indentation	1
H					
I					
J					
K

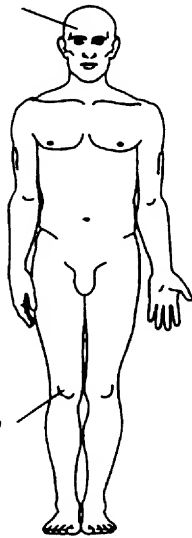
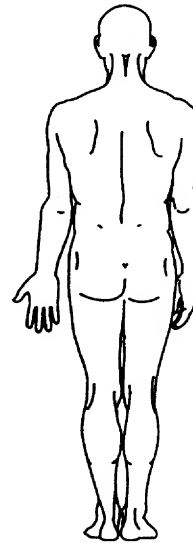
INDICATE LOCATION OF INJURIES.

During the frontal impact, the right-front passenger moved forward into the instrument panel and windshield. He sustained a contusion to the right side of his forehead, probably due to contact with the windshield and/or rear-view mirror, (slides 51 and 52) as evidenced by the starred windshield, skin oil on the windshield, and (slide 53) the cracked rear-view mirror glass. He sustained a contusion to his right knee due to contact with the knee bolster/glove box, (slides 54) as evidenced by an indentation into the plastic knee bolster cover.

Contusion,  
right side  
of forehead  
(1)

Contusion,  
right knee  
(1)
